Integrating Condition Indicators and Usage Parameters for Improved Spiral Bevel Gear Health Monitoring

*Paula J. Dempsey, Robert F. Handschuh, and Irebert R. Delgado
Glenn Research Center, Cleveland, Ohio*

Prepared for the
69th Annual Forum and Technology Display (Forum 69)
sponsored by the American Helicopter Society (AHS)
Phoenix, Arizona, May 21–23, 2013

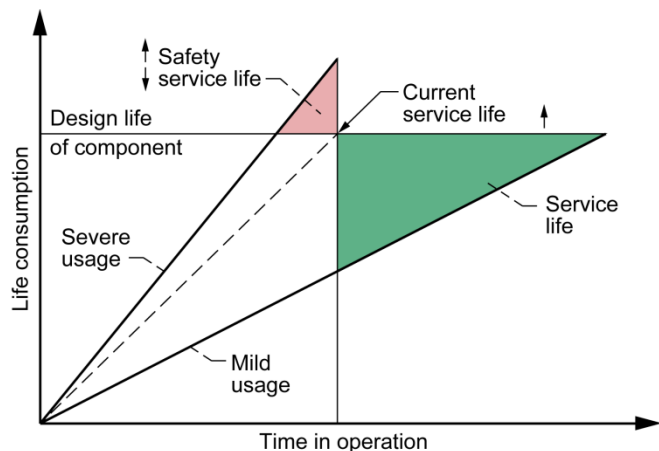
Figure 1.—Illustration of life consumption based on usage (Ref. 2).

Usage monitoring is another important HUMS function. Helicopter transmission components are designed per assumed flight regimes and usage spectrums. Usage monitoring consists of measuring torque, operating hours, flight regimes and operating conditions to track component “actual” usage. If “actual” usage is measured, and component usage is less severe than the life it was designed for, the time in operation of a component may be increased as shown in the green in Figure 1. If component usage is more severe than the life it was designed for, the time in operation of a component should be decreased for safety reasons as shown in the red in Figure 1.

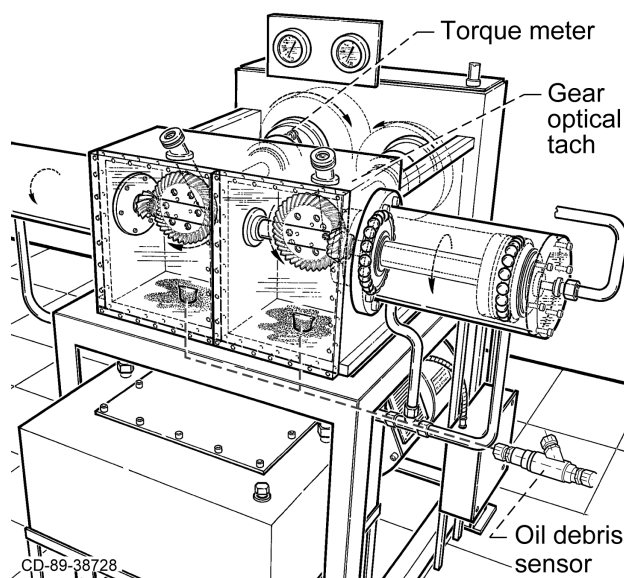
Figure 2.—Spiral Bevel Gear Fatigue Rig.

Tests were performed in the NASA Glenn Spiral Bevel Gear Test Rig at NASA Glenn Research Center. A detailed description of this test facility can be found in References 4 and 5. The Spiral Bevel Gear Test Facility is illustrated in Figure 2. In addition to developing gear health monitoring tools, the test facility has been used to study the effects of gear material, gear tooth design, and lubrication on the fatigue strength of gears. Two sets of spiral bevel gears are installed in the test rig and tested simultaneously. Facing the gearboxes per Figure 3, the left gear set (pinion/gear) is referenced as left and the right gear set (pinion/gear) is referenced as right.

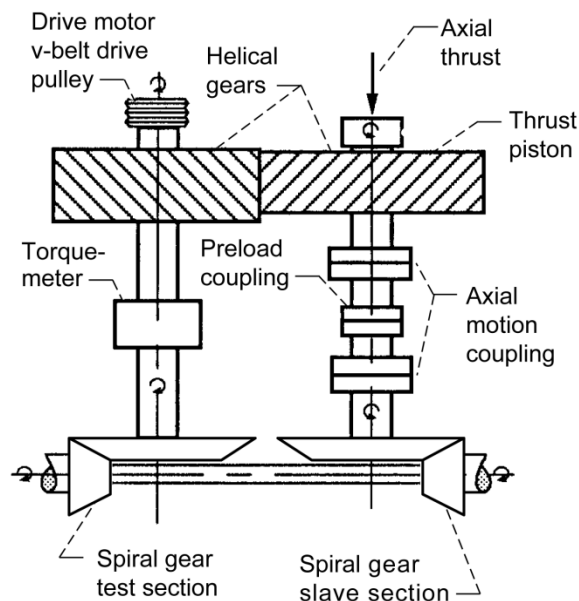
Figure 3.—Cross section of Spiral Bevel Gear Fatigue Rig.

Figure 3 shows the cross-sectional view of the rig driveline. The facility operates in a closed-loop arrangement where the load is locked into the loop via a split shaft and a thrust piston that forces a floating helical gear axially into mesh. The drive motor supplies the facility with rotation and loop losses via v-belts to the axially stationary helical gear. The spiral bevel gears on the left side operates where the pinion drives the gear in the normal speed reducer mode and the right side of the facility acts as a speed increaser. However, the concave side of the pinion is always in contact with the convex side of the gear on either side of the test facility. Load and speed of the left side gear output shaft are monitored by torque and speed sensors.

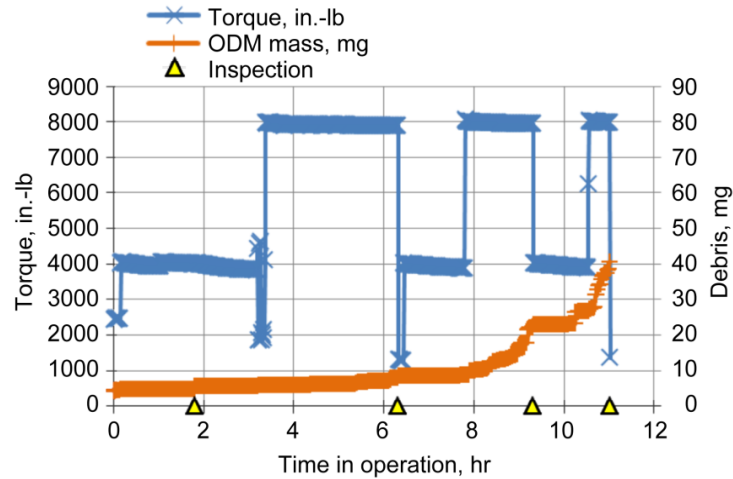
Figure 4.—Debris generated and torque during test 1.

Figure 4 to Figure 9 are plots of the damage progression to the gear teeth and the effect of torque during the testing of the three gear sets. The first plot in Figure 4, Figure 6 and Figure 8, torque, in inch-pounds (in.-lb), plotted in blue per the left y-axis. Debris generated in milligrams, an indication of fatigue damage progressing, is plotted in orange per the right y-axis. The yellow diamonds on the x-axis indicate hours for gear teeth inspections. Representative photos of gear and pinion teeth damage modes and their progression at the inspections intervals are shown in the second figure. The six figures will be discussed in the following paragraphs.

For test 1, Table 5 displays the rate of debris generation measured was at 8.96 mg/hr when progressive macropitting (4.3.2) was first observed on several teeth as seen in Figure 4 and Figure 5. The rate decreased to 3.75 mg/hr when the torque dropped to 4000 in.-lb. The debris generated then increased from 3.75 to 27.69 mg/hr when torque increased from 4000 to 8000 in.-lb, and spalling macropitting (4.3.4) was observed on five gear teeth as seen in Figure 5.

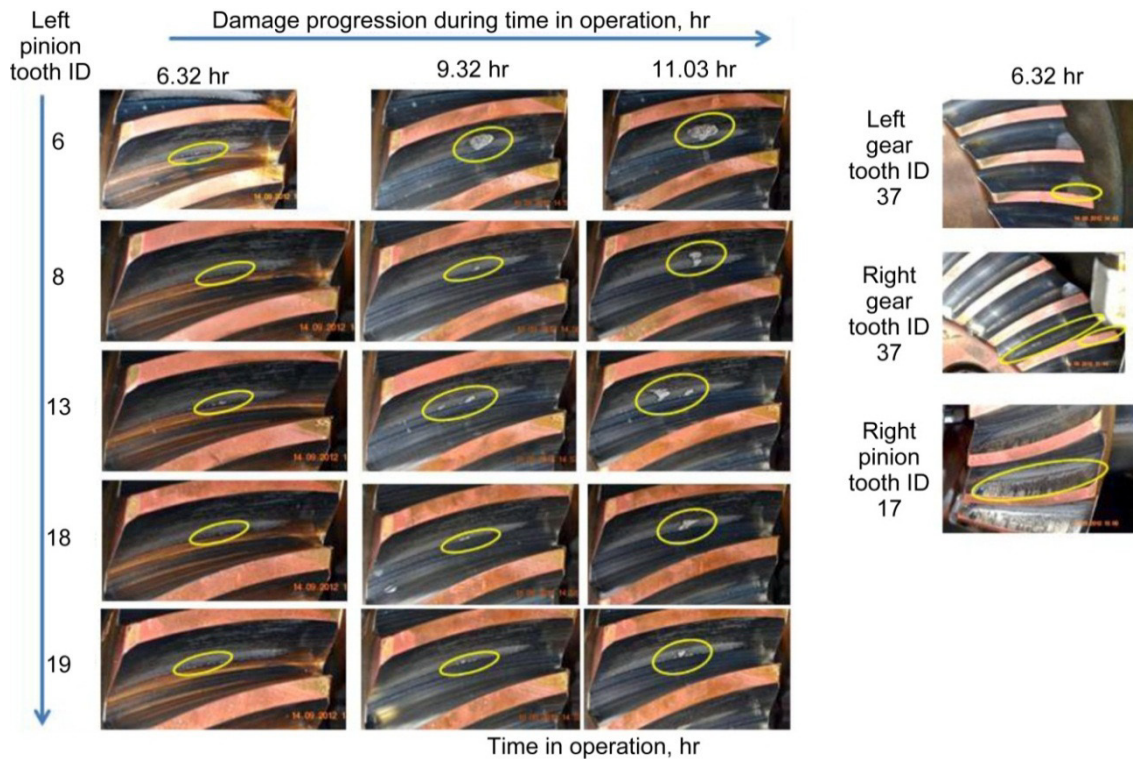
Figure 5.—Damage conditions on teeth during test 1.

For test 1, Figure 5 illustrates the progression of damage to five left pinion teeth. The other photos are representative pictures of one left gear tooth, on right gear tooth and one pinion tooth. The damage to these gears did not change after the initial inspection. For the left pinion, no macropitting was

observed on the pinion teeth 6 hr into the test. Nine hours into the test, 4.3.4 was observed on two pinion teeth. Eleven hours into the test, 4.3.4 was observed on five teeth.

Gear and pinion temperatures and applied loads have significant effects on gear and pinion life. The effect of load on the progression of damage to the gear teeth was observed in Figure 5, Figure 7 and Figure 9. The applied torque affects contact and bending stresses on all spiral bevel geared systems. In many cases the gears must operate at elevated temperatures. Elevated temperatures can also have detrimental effects on the aspects of a design that have to do with bending fatigue (material capability to carry load at elevated temperatures), contact fatigue (pitting—surface degradation) and scoring (surface interaction through the lubricating film thickness) that decrease the life of the gears.

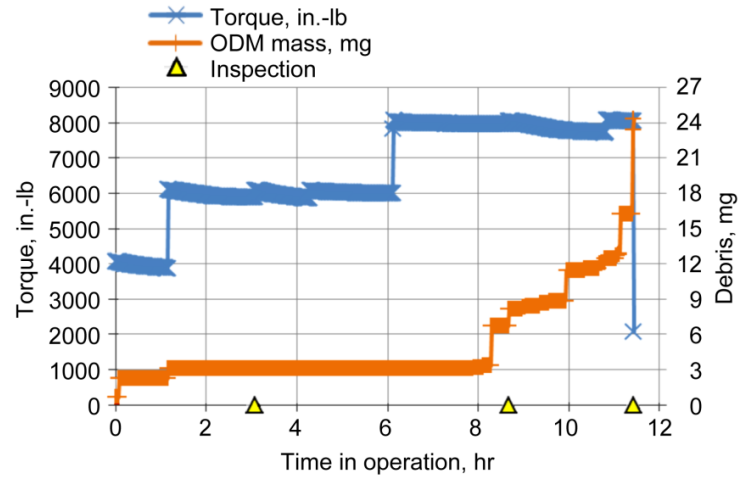
Figure 6.—Debris generated and torque during test 2.

For test 2, Table 6 displays the rate of debris generation measured increased when torque increased from 6,000 to 8,000 in.-lb per Figure 6. For this test, the torque was not decreased when the macropitting was observed on the teeth per Figure 7. The 6.37 mg/hr rate of debris generation when spalling macropitting (4.3.4) was observed at 8,000 in.-lb was higher than the 3.75 mg/hr rate of debris generation when spalling macropitting (4.3.4) was observed at 4,000 in.-lb for test 1.

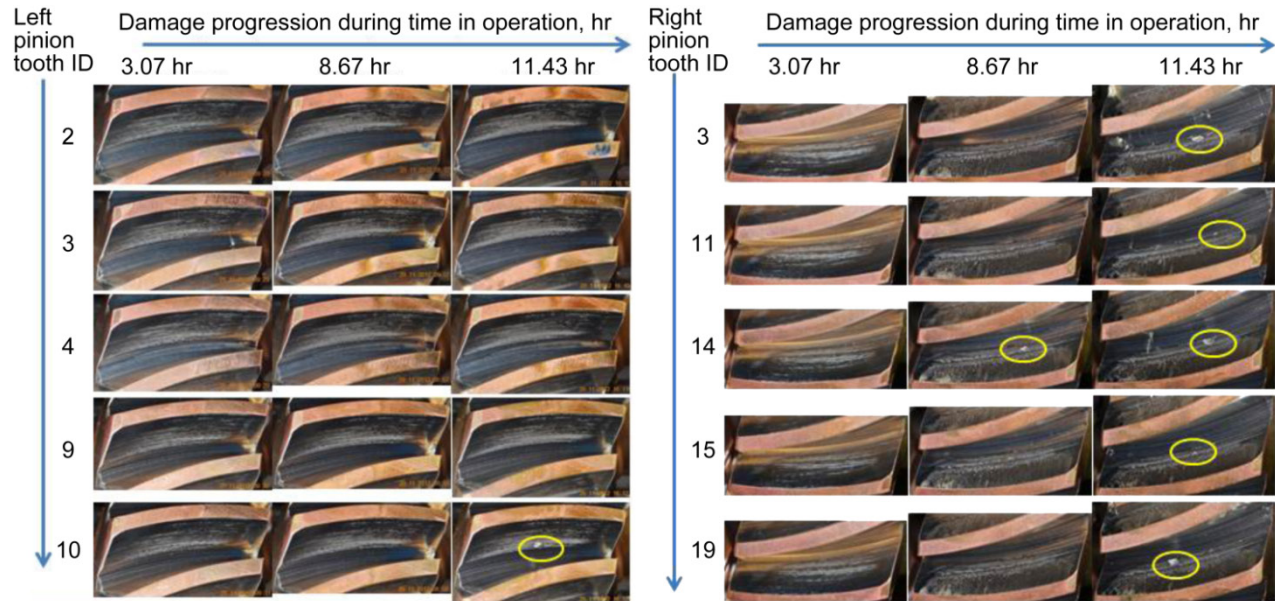
Figure 7.—Damage conditions on teeth during test 2.

For test 2, Figure 7 illustrates the progression of damage to six right and left pinion teeth. No macropitting was observed on the pinion teeth 3 hr into the test. Eight hours into the test, a pit was observed on a right pinion tooth. Several more pits were observed 11 hr into the test on the right pinion teeth and one pit on a left pinion tooth.

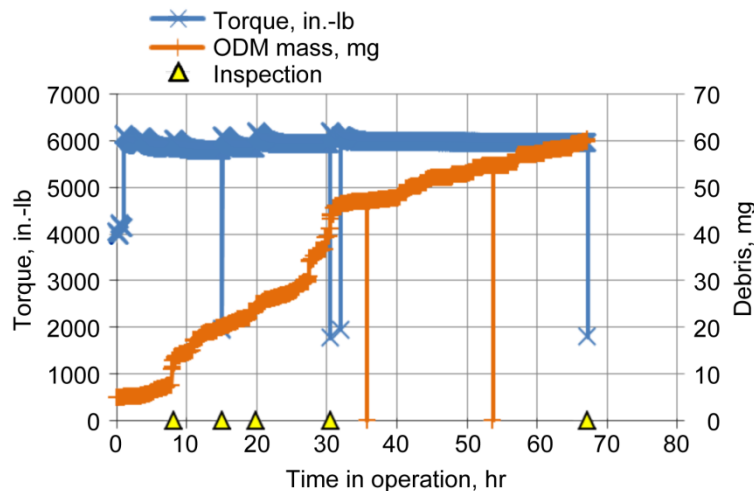
Figure 8.—Debris generated and torque during test 3.

For test 3, Table 7 displays the rate of debris generation measured was at 0.51 mg/hr rate of debris generation when spalling macropitting (4.3.4) was observed at 6000 in.-lb per Figure 8 and Figure 9. This rate was lower than the 3.75 mg/hr rate of debris generation when spalling macropitting (4.3.4)

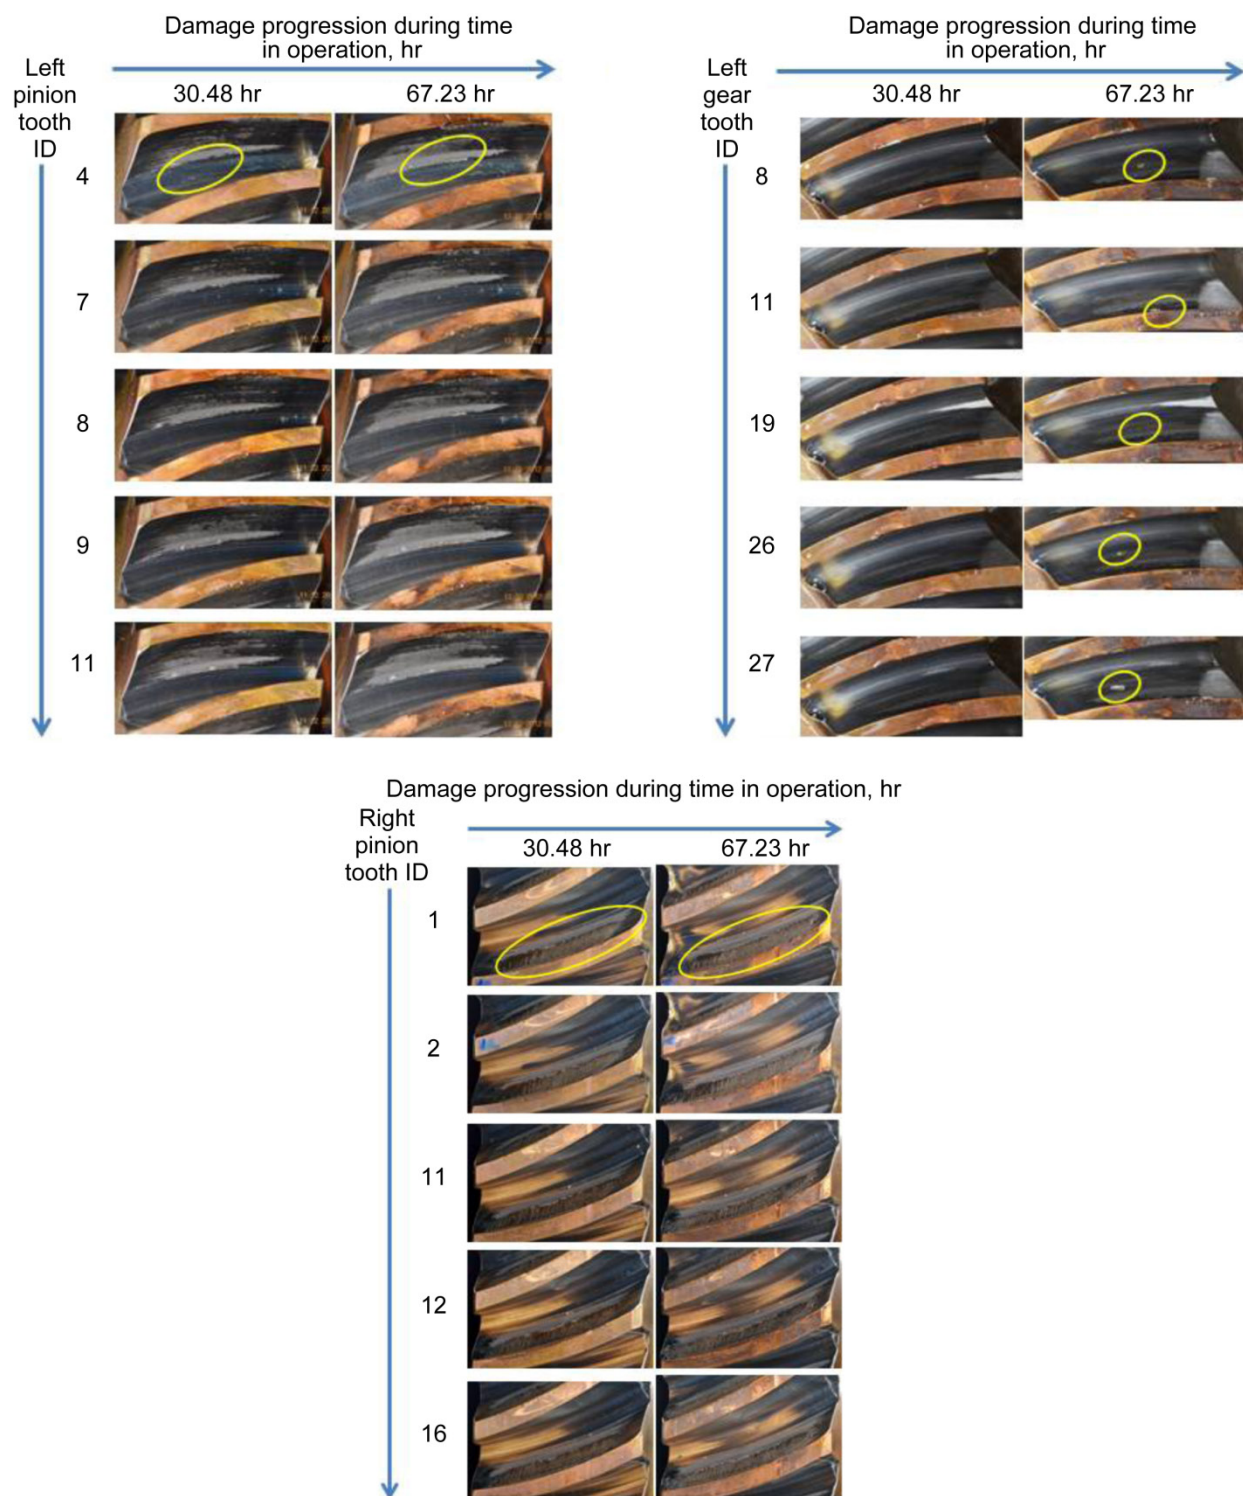
Figure 9.—Damage conditions on teeth during test 3.

For test 3, Figure 9 illustrate no macropitting was observed on the pinion teeth 30 hr into the test. Sixty-seven hours into the test, several pits were observed on the left gear teeth and micropitting on both the left and right pinion teeth. The torque remained at 6000 in.-lb during the test.

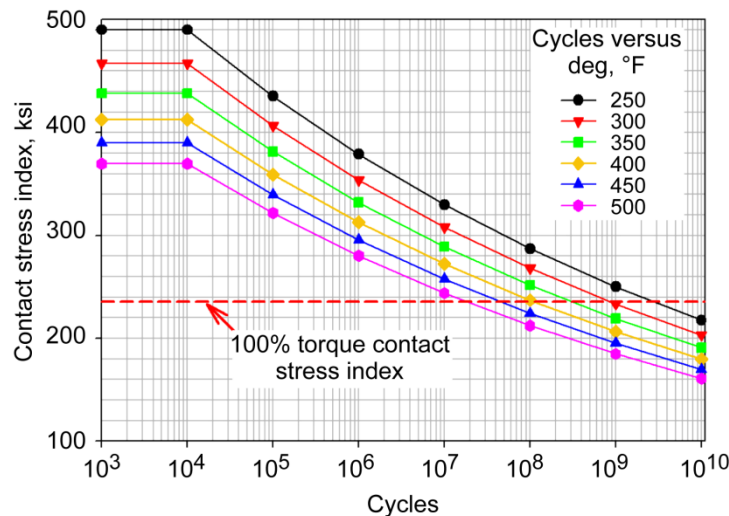
Figure 10.—Blank temperature effects on allowable contact stress, 99 percent reliability.

Per the highlighted line in Table 9 at 100% torque (8000 in.-lb gear torque), the life cycles at 500 °F pinion temperature is significantly lower than at 400 and 300 °F. An S-N curve of cycles versus allowable stress index was generated for the contact fatigue reliability based on blank or gear tooth temperatures for this gear design and is shown in Figure 10. The number of cycles is shown on the x-axis and the contact stress index is shown on the y-axis. The red dashed horizontal line is the contact stress index at 8000 in.-lb gear torque, 3707 in.-lb pinion torque. The blank temperature is the pinion tooth temperature. During the three gear tests the inlet oil temperatures ranged from 240 to 265 °F. The gear and pinion temperatures can be significantly higher than the inlet oil temperatures. Pinion tooth root temperatures were measured in this test rig on another gear design with 100 °F oil inlet temperatures at comparable load that ranged from 200 to 225 °F, over 100 °F above the oil inlet temperature (Ref. 11).
